Sample report – Conveyor Belt Condition Monitoring

Rev	Description	Compiled by	Date
A	Belt Condition Report	Engineer ID	11-10-2017

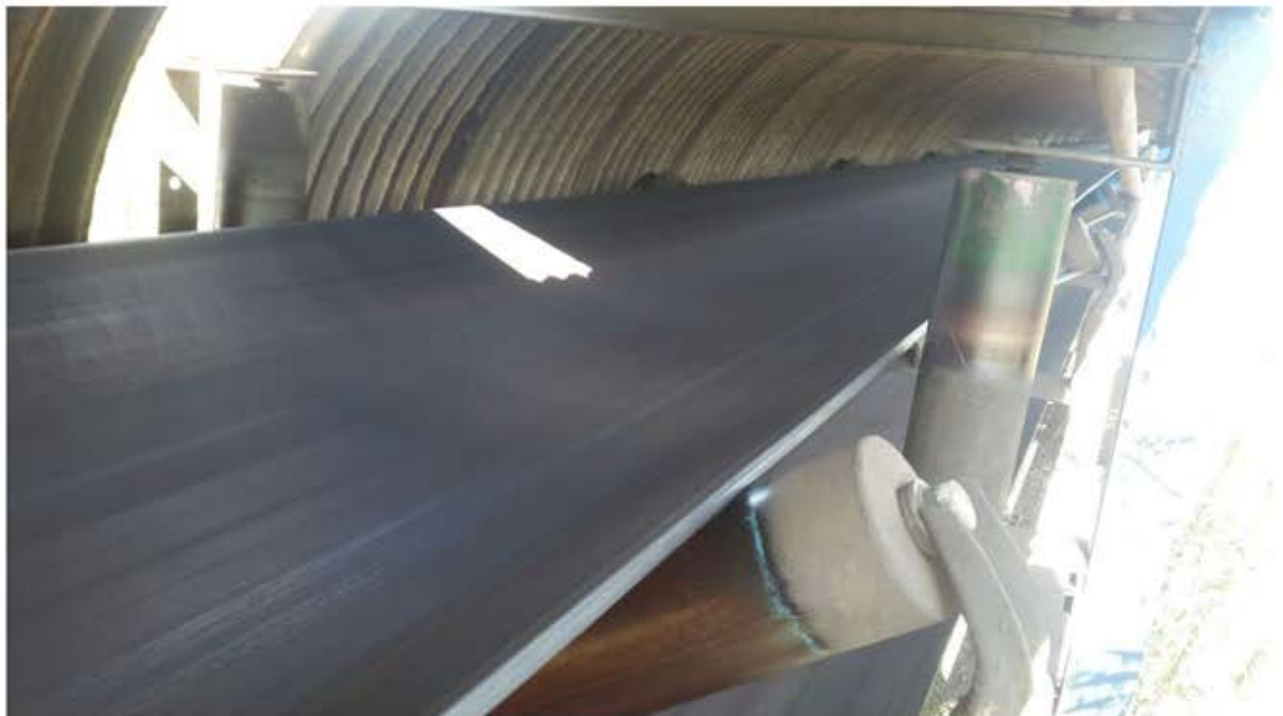
It was noted that belt mistracking was address through the use of near vertical idlers. See photograph. This method has potential to harm the edges of the belt after prolonged contact between these idlers and the belting. Self-tracking idler sets are a preferable solution.

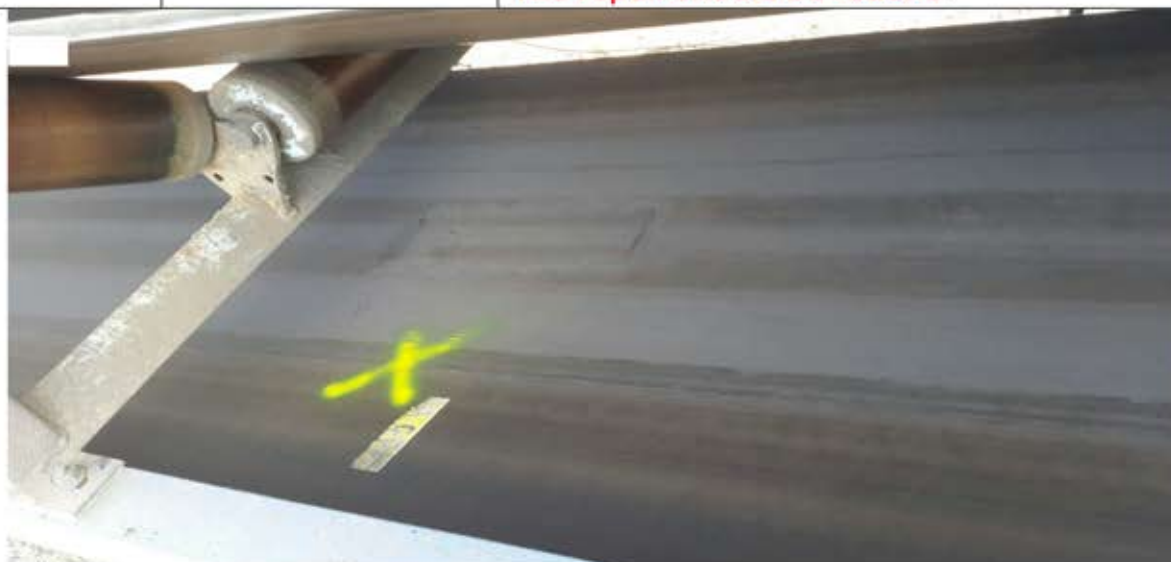
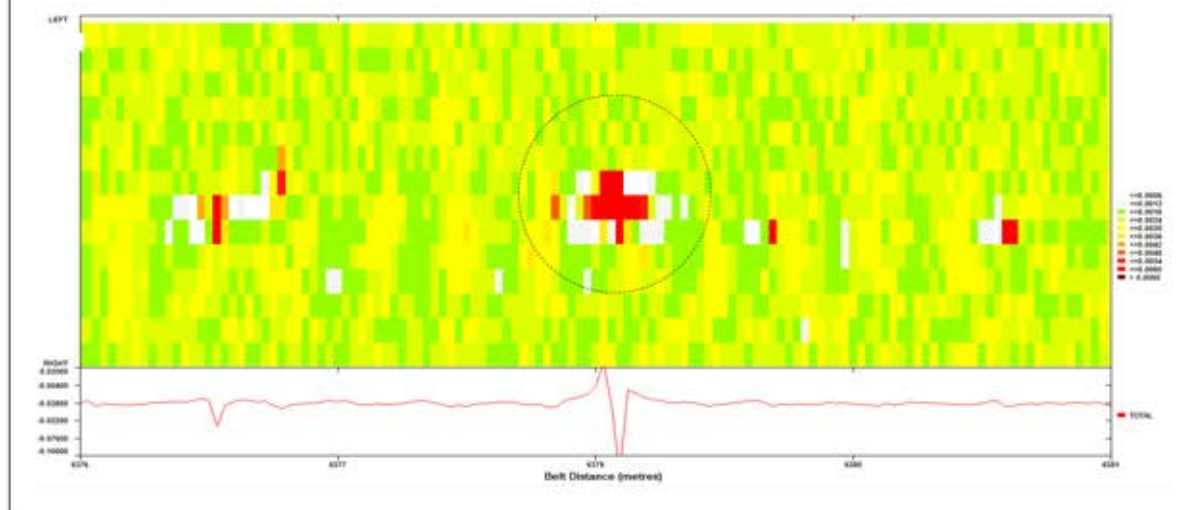
Event	Location	Findings
1	19 m after splice 3 marked 18-03-17 towards splice 4 marked BR16-5-12.	There are broken / damaged cords in the centre of the belt. Up to 17 % of the full belt width is affected. There is an old patch in place. The repair should be redone.

1. Replace Splice 35 if not already done.
2. Splice out Event 5.
3. Replace Splice 22.
4. Replace Section A if not already done.
5. Redo the repairs at Events 1 and 4.
6. Whenever punctured covers are encountered such as in Section B, repairs must be effected to prevent ingress of moisture.
7. Replace Section C.
8. Replace Splice 53.
9. Re-scan the conveyor after a further 6 months of normal operation to verify the repairs, identify new damage and to detect any growth in the old damage.

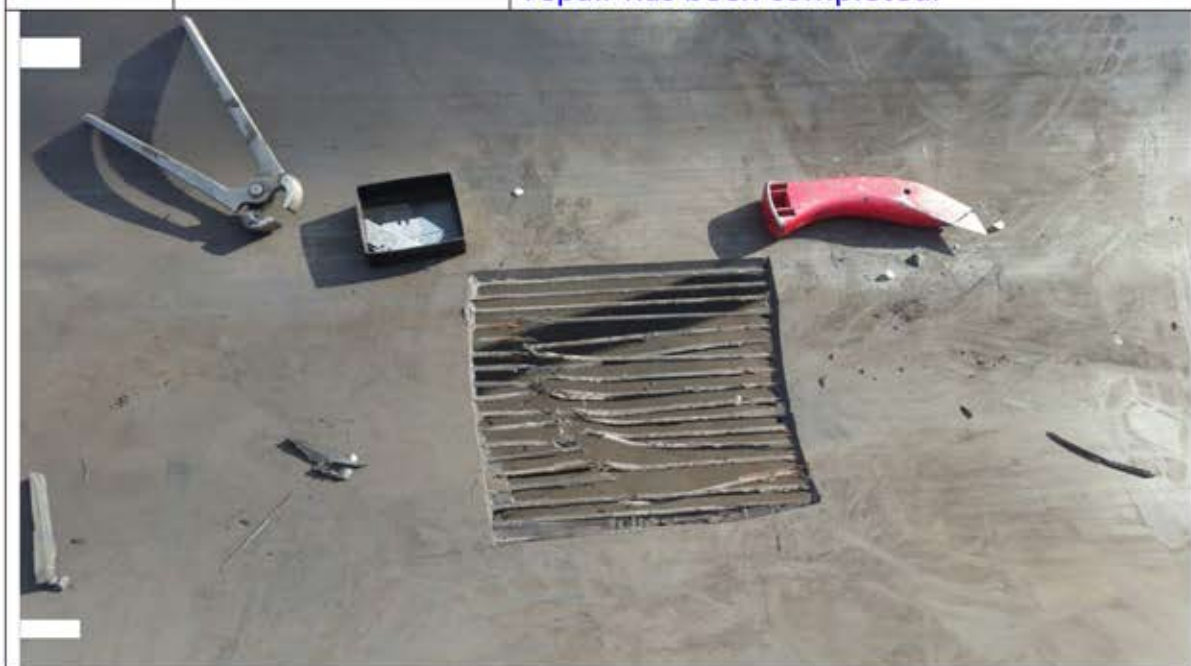
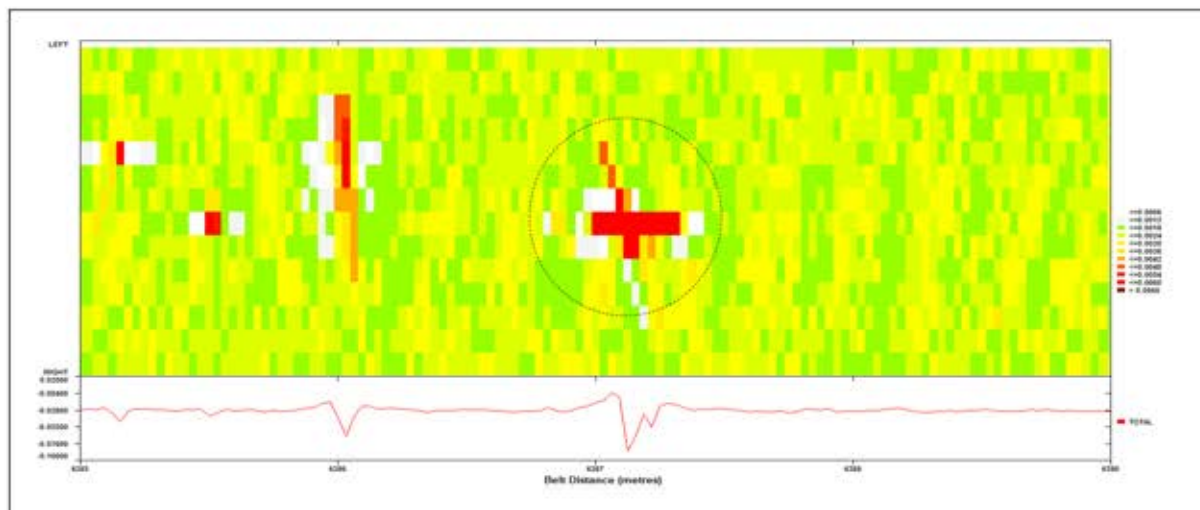
Event	Location	Findings
2	28 m after splice 3 marked 18-03-17 towards splice 4 marked BR16-5-12.	<p>There are broken / damaged cords in the centre of the belt. Up to 17 % of the full belt width is affected.</p> <p>Repair of the damage was in progress at the time of the scan. It is assumed that the repair has been completed.</p>

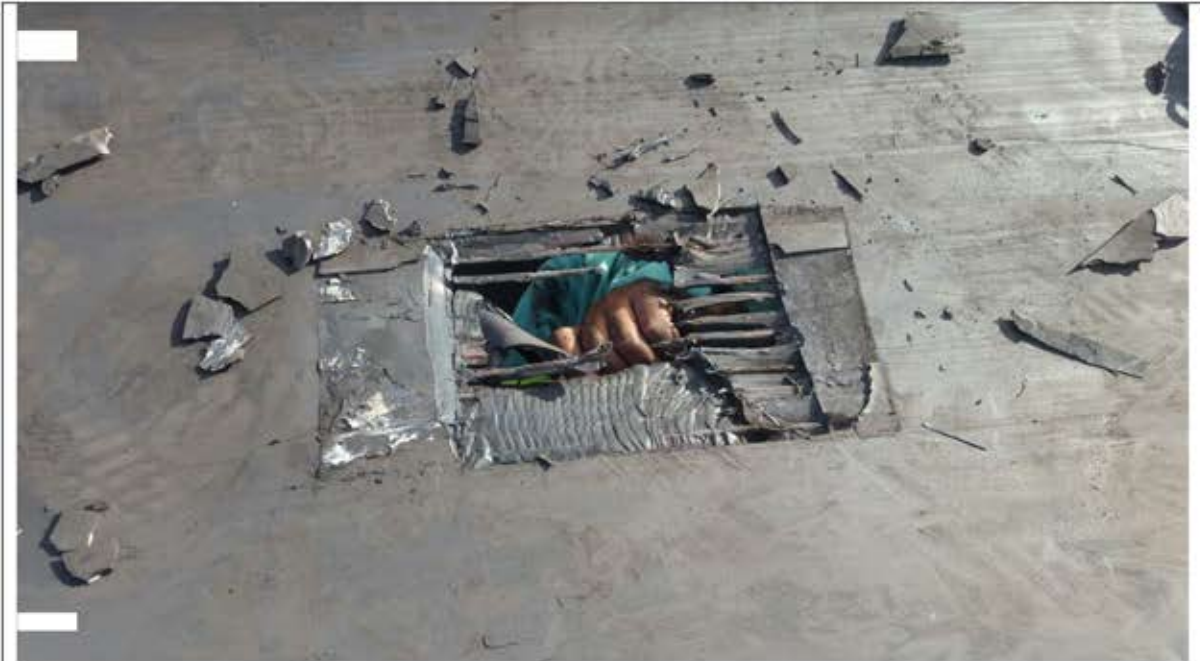
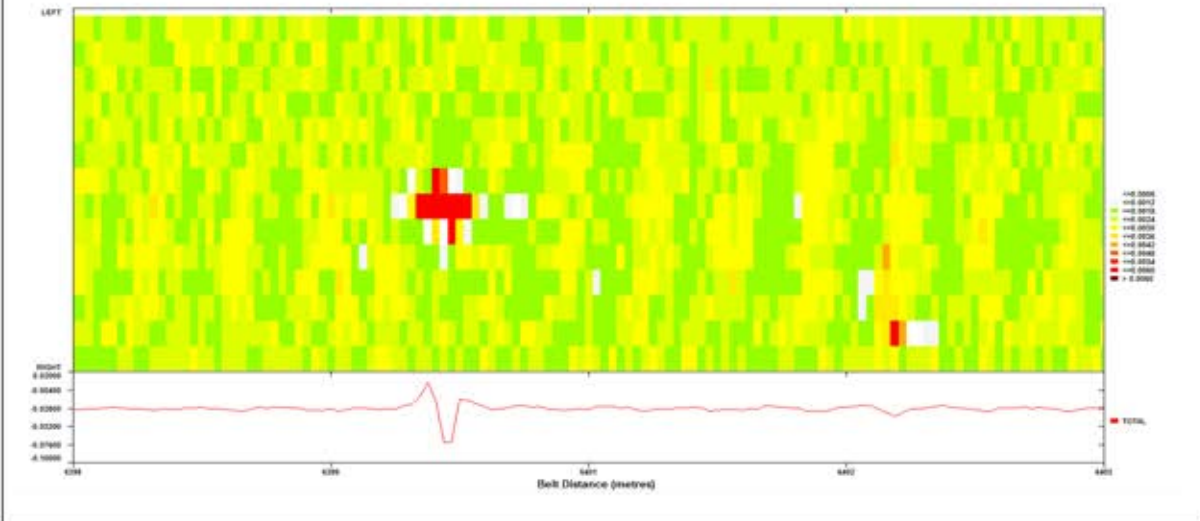
Event	Location	Findings
3	40 m after splice 3 marked 18-03-17 towards splice 4 marked BR16-5-12.	<p>There are broken / damaged cords in the centre of the belt. Up to 17 % of the full belt width is affected.</p> <p>Repair of the damage was in progress at the time of the scan. It is assumed that the repair has been completed.</p>

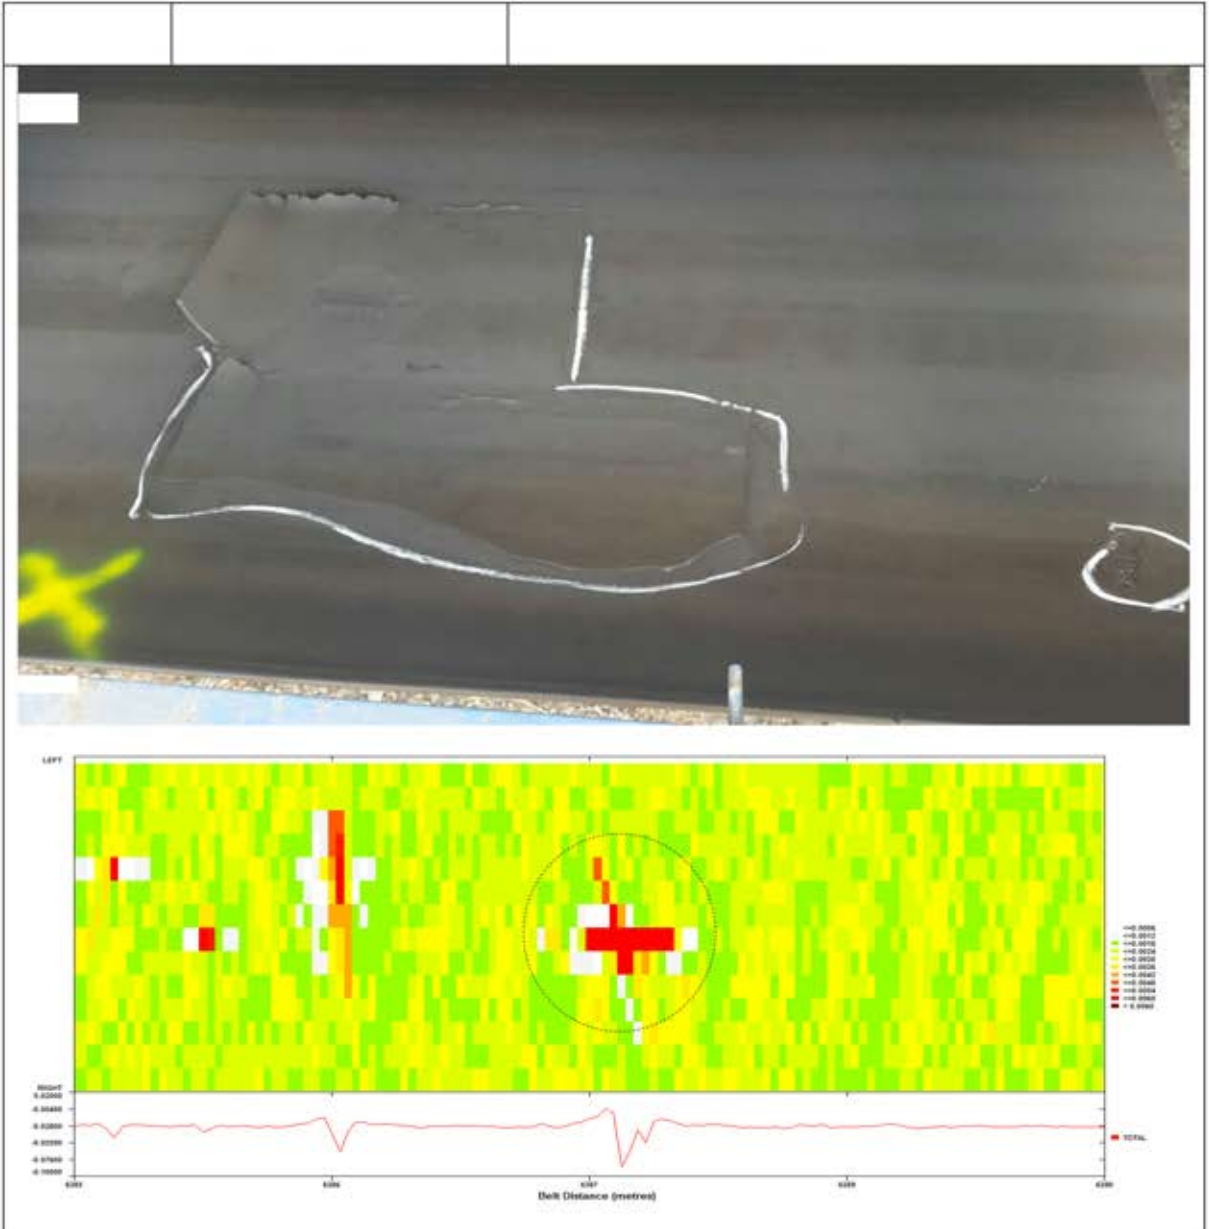
Event	Location	Findings
4	2 m behind splice 10 marked 2028GY towards splice 9 marked 12-10-05 ceza.	There are broken / damaged cords in the right side of the belt. Up to 17 % of the full belt width is affected. There is a patch which is coming loose. The repair should be redone.

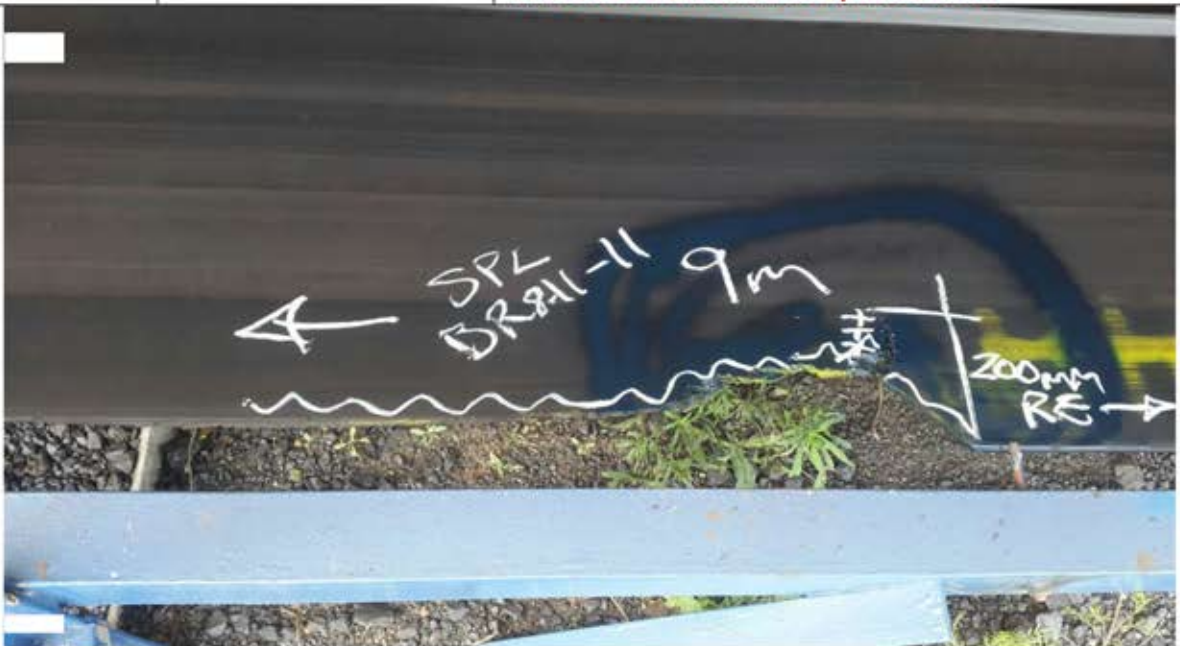
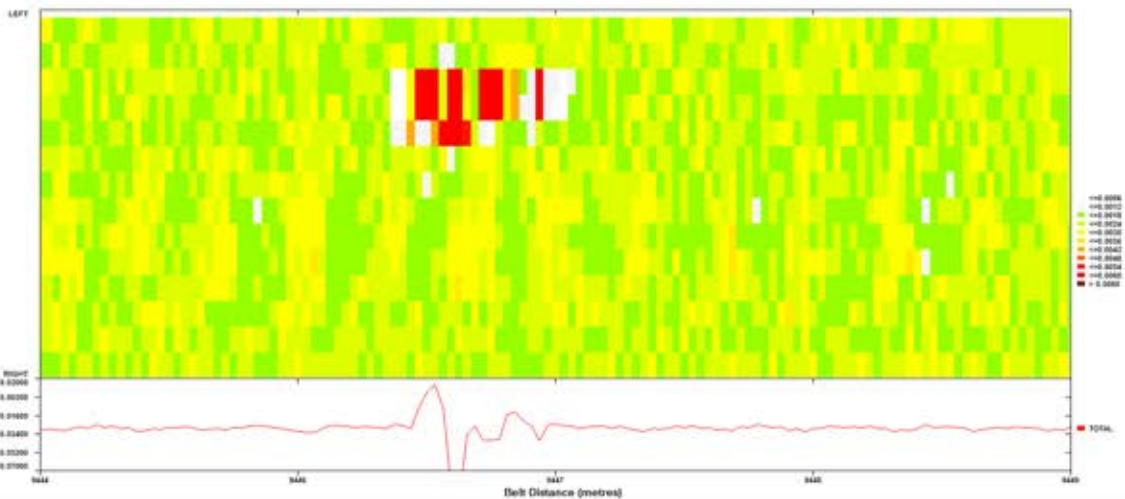
The most severe event (Event 5) has damage affecting up to 20 % of the full belt width at the edge of the belting. There is a section missing and a lateral tear. This event should be spliced out.

Event	Location	Findings
5	9m behind splice 34 marked BR 8-11-11 towards splice 33 marked 29-5-14.	<p>There are broken / damaged cords at the edge of the belt. Up to 20 % of the full belt width is affected. A section of the belting is missing and the belting is torn.</p> <p style="color: red;">The event should be spliced out.</p>

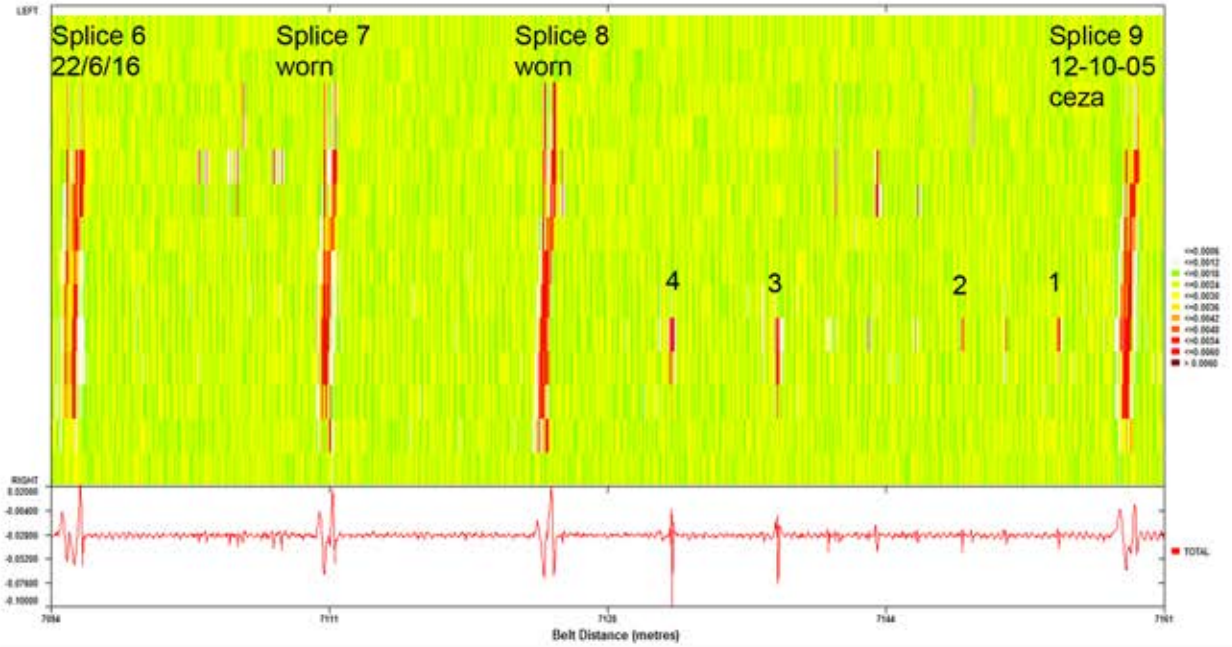
Section A, 63 m from Splice 6 to Splice 9 including Splices 7 and 8.

There are multiple damage events and splices which are close to each other. This section was scheduled to be replaced the day of the scan. If not done, it should be replaced as soon as possible.

Section A showing multiple damage events including those in the photos below. This section was being replaced at the time of the scan.

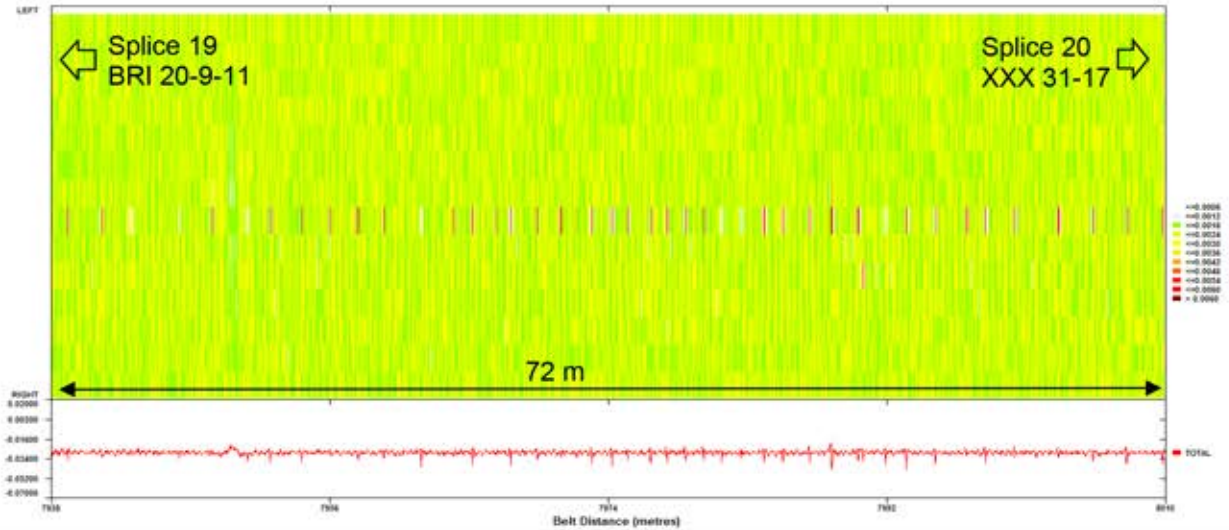
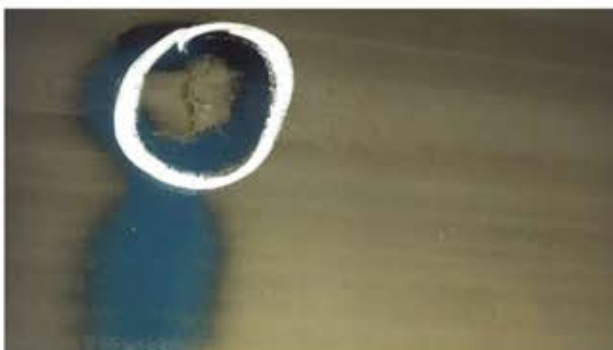
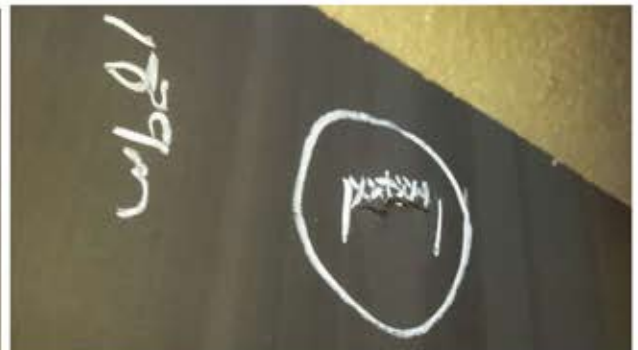
It was also noted that there are multiple instances of what is almost certainly **entrapment damage**.

Material gets lodged between a pulley and the belting resulting in repeated damage of fixed frequency in the same plane of the belting. Apart from damaging the steel cords, it can cause puncturing of the covers allowing the ingress of moisture. This will ultimately result in corrosion and weakening of the cords.

Section B showing damage most likely caused by entrapment. Starting 51 m after Splice 19 for approx. 72 m in the direction of Splice 20. The regular size, location and frequency indicate entrapment between belting and pulley to be the cause of the damage. Although less than 10 % of the full width of the belt is affected in each instance, the covers are being punctured allowing for ingress of moisture and subsequent corrosion setting in. See photographs.

All measures and precautions should be taken to prevent product spillage along the length of the conveyor and at the on and off load points.

Where the covers are punctured, repairs must be effected to prevent ingress of moisture. The entrapment of material between belting and pulleys should be investigated and minimized.

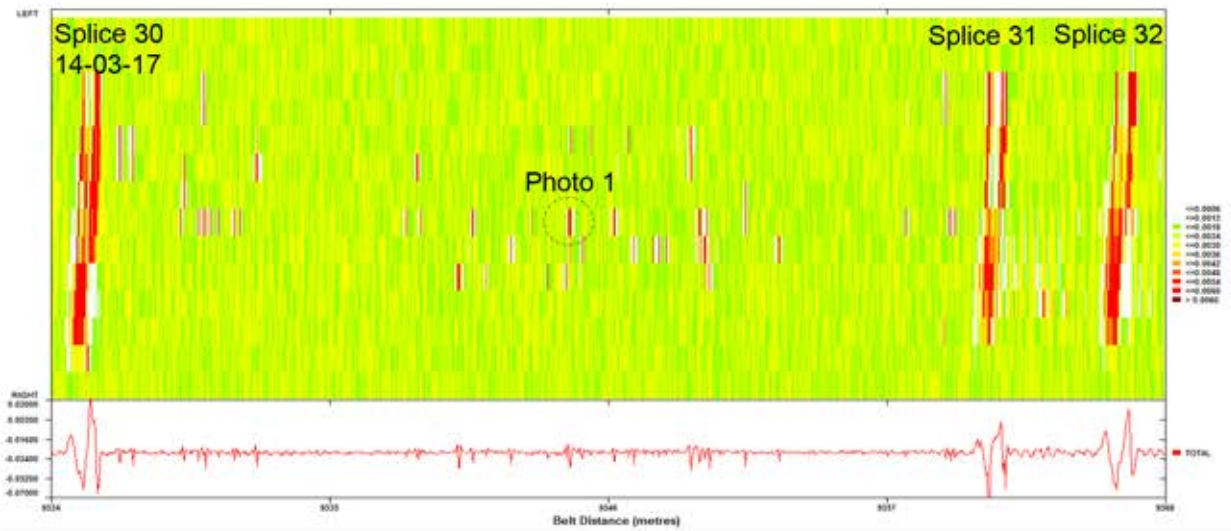
This section has old, damaged belting with numerous small damage events, some with punctured covers. Splice 31 and the adjacent belting have been patched at the edge. Splice 32 and the adjacent belting have edge damage. The section should be replaced at a lower priority.

Section C showing damage to the old belting between Splices 30 and 31. The belting is punctured in several locations. Splice 31 and the belting immediately adjacent have been patched. Splice 32 and the belting immediately adjacent have edge damage. **The section should eventually be replaced at a lower priority.**

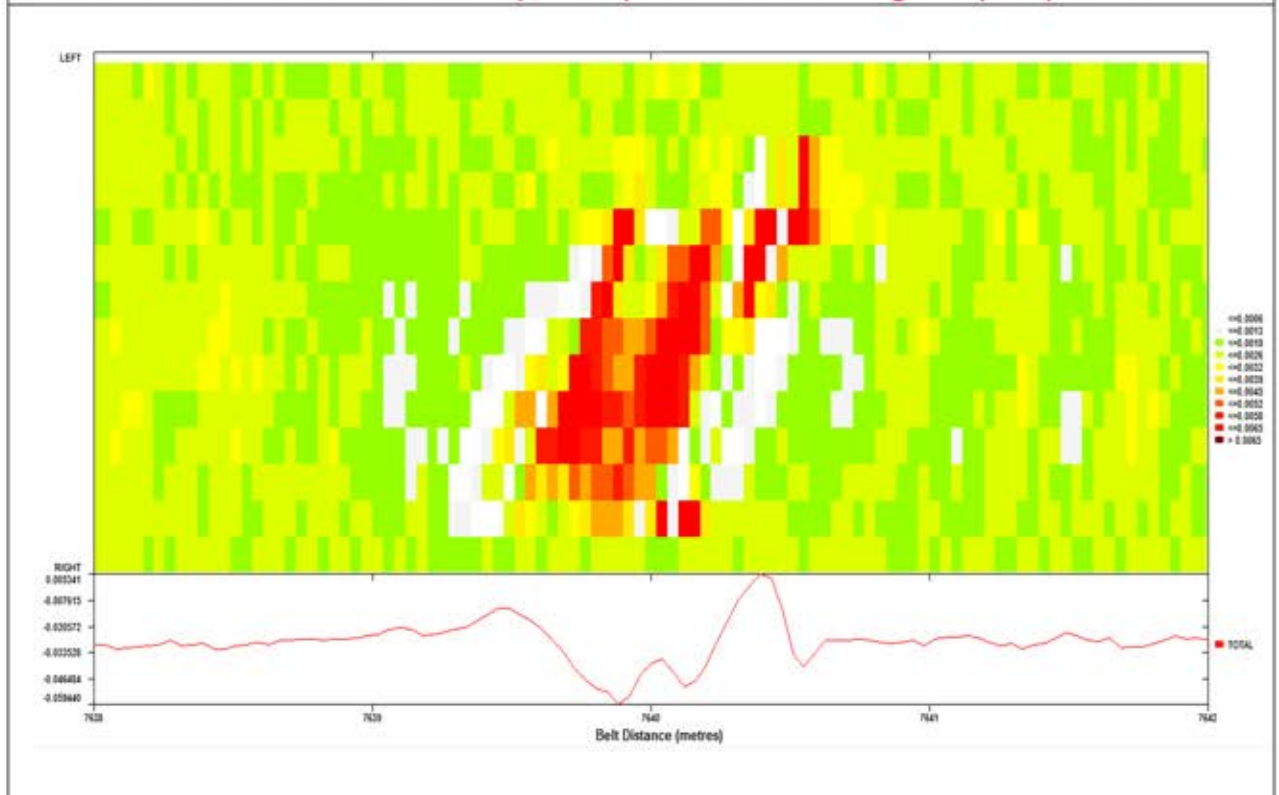
Splice 15 (worn markings)

The splice signature shows an acceptable pattern for a single stage splice.

Visual inspection revealed small air pockets under the covers.

No immediate action is necessary, the splice should be regularly inspected.

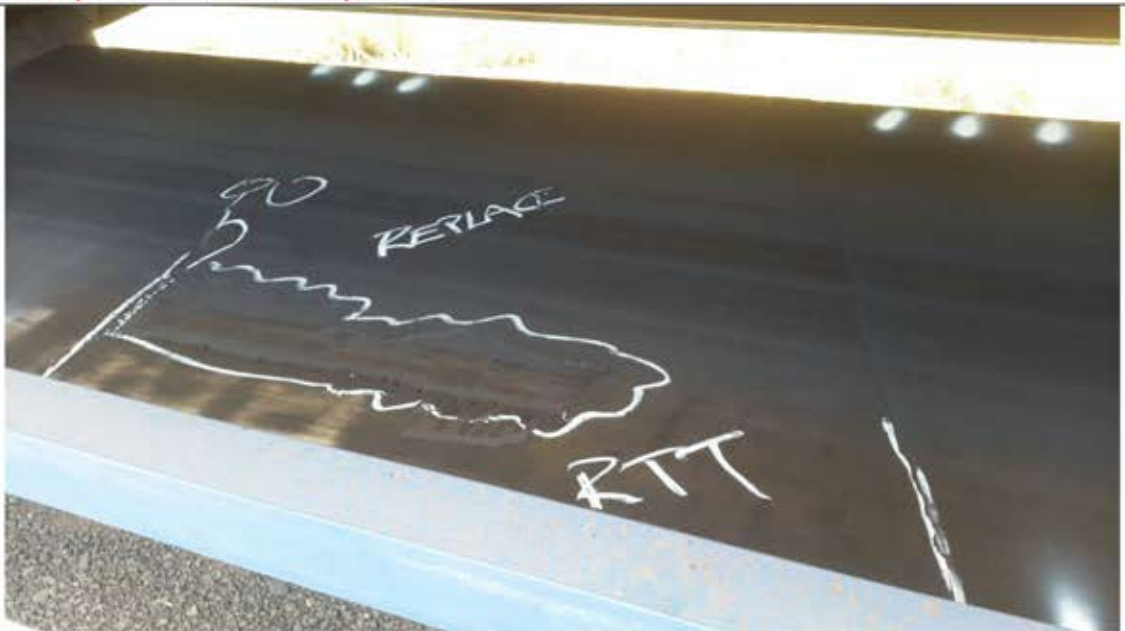
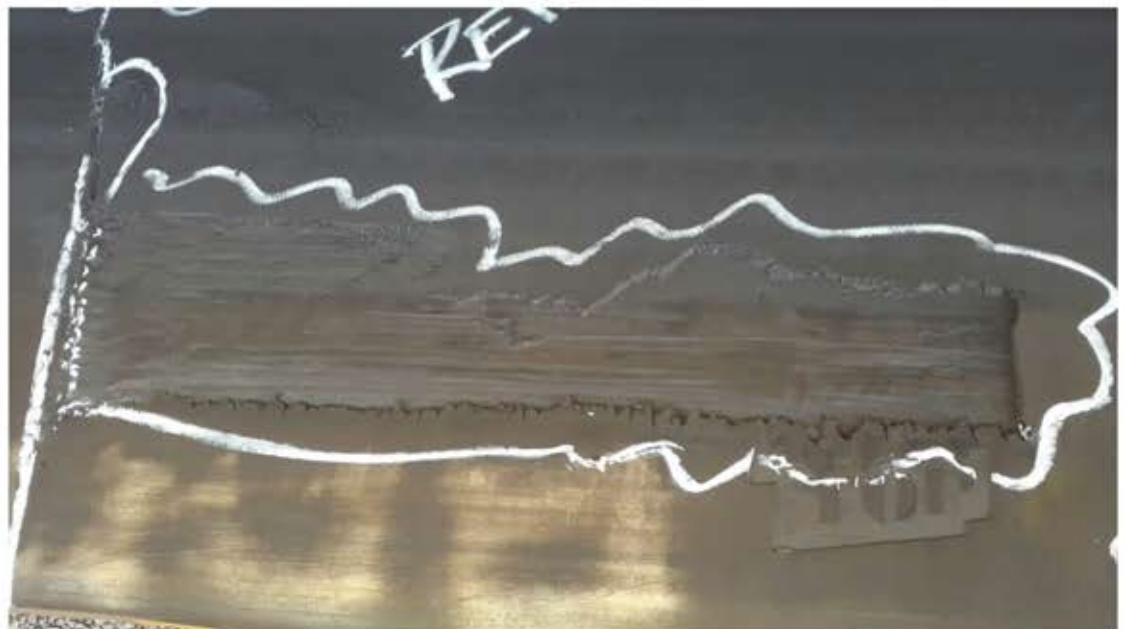
Splice 22 (RTT.. worn markings)

The splice signature shows a normal pattern for a single stage splice:

Visual inspection revealed a large section of cover being ripped off from the leading skive back.

The splice should be replaced.

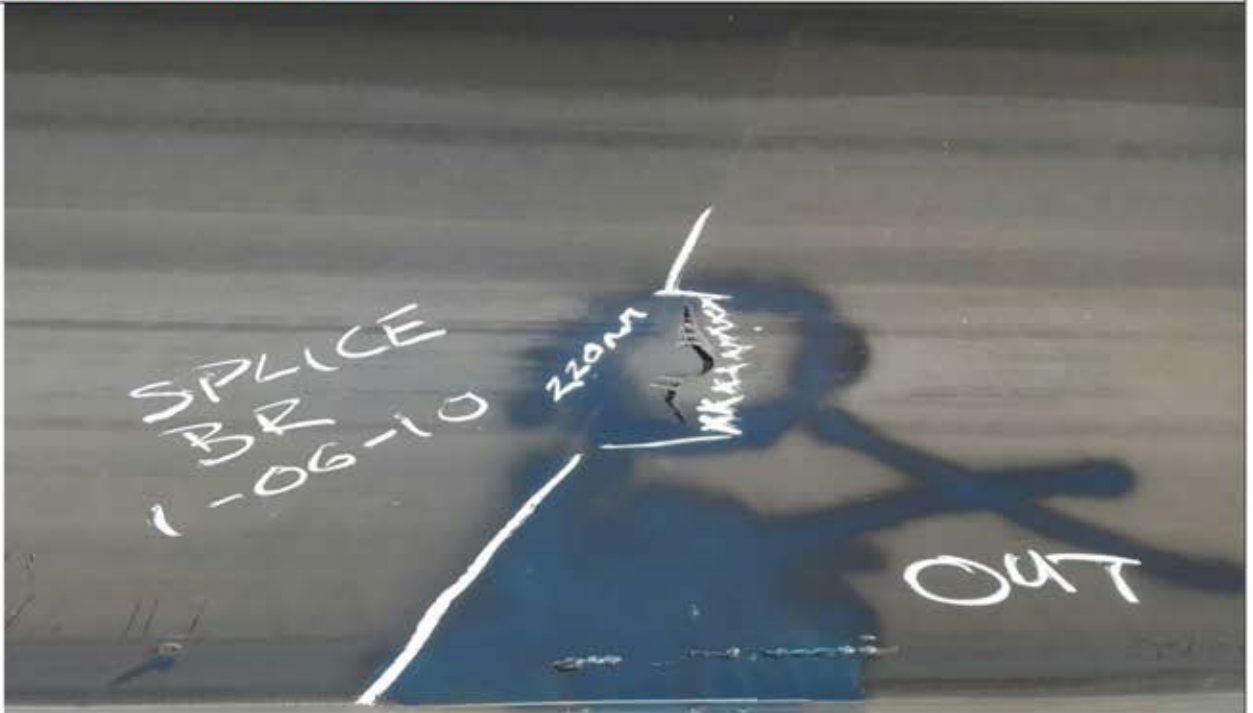
Splice 35(BR 1-06-10)

The splice signature shows a normal pattern for a single stage splice.

However, visual inspection revealed damage to the trailing skive of the splice. The cover is punctured and the underlying steel cords are broken and protruding.

The splice was scheduled to be replaced on the day of the scan. If it was not replaced, it should be done ASAP.

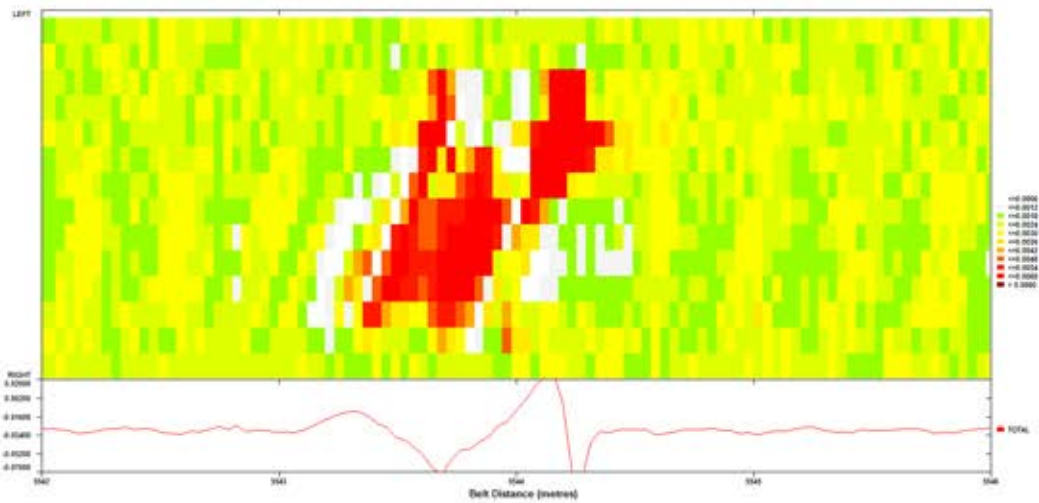
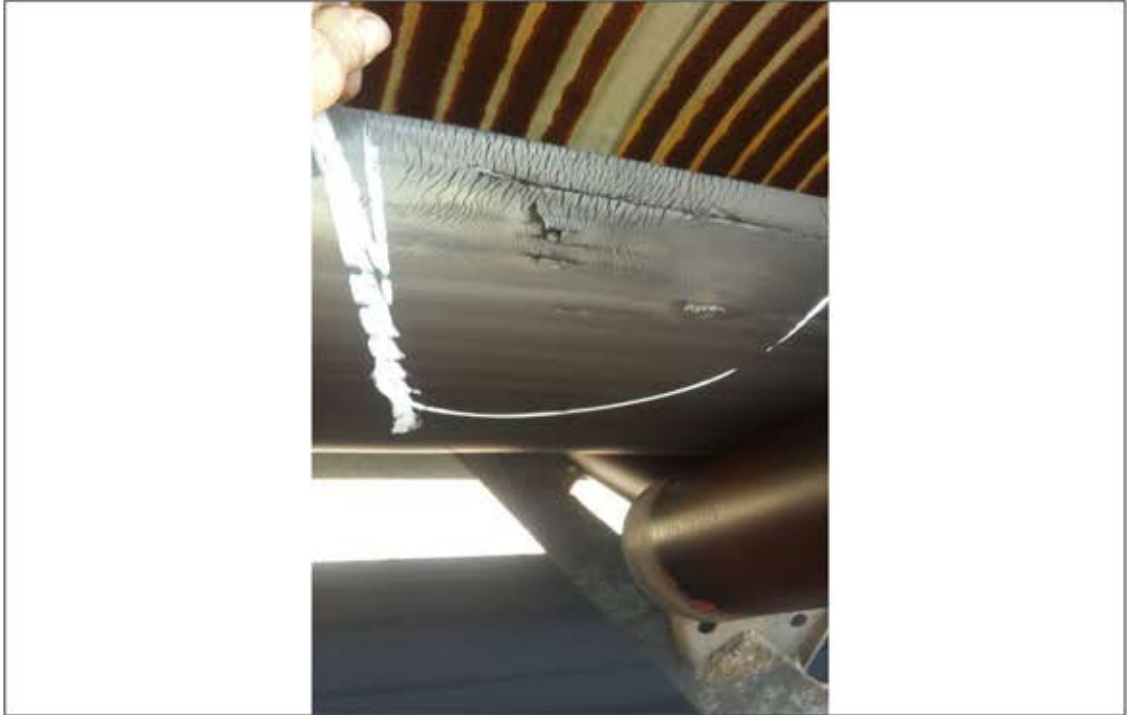
Splice 53 (worn markings)

The splice signature shows an abnormal pattern for a single stage splice.

Damage is indicated in the left section of the splice.

Visual inspection showed the splice to old and worn with edge damage.

The splice should be replaced at a lower priority.
