Sample report – Conveyor Belt Condition Monitoring

Rev	Description	Compiled by	Date
A	Belt Condition Report	Engineer ID	11-10-2017

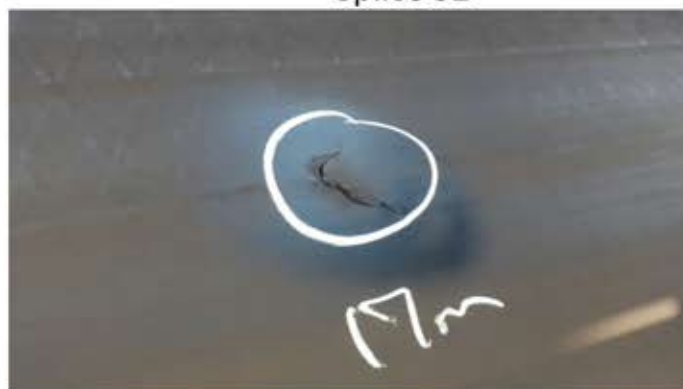
Section C showing damage to the old belting between Splices 30 and 31. The belting is punctured in several locations. Splice 31 and the belting immediately adjacent have been patched. Splice 32 and the belting immediately adjacent have edge damage. **The section should eventually be replaced at a lower priority.**
